CERTIFIED TESTING LABORATORIES

Report No.: CTLA-679WE

Tests Conducted: PA 201, Large Missile PA 202, PA 203, (with no deviations)

Model Designation : Aluminum Clad Wood Single and Double Outswing French Doors

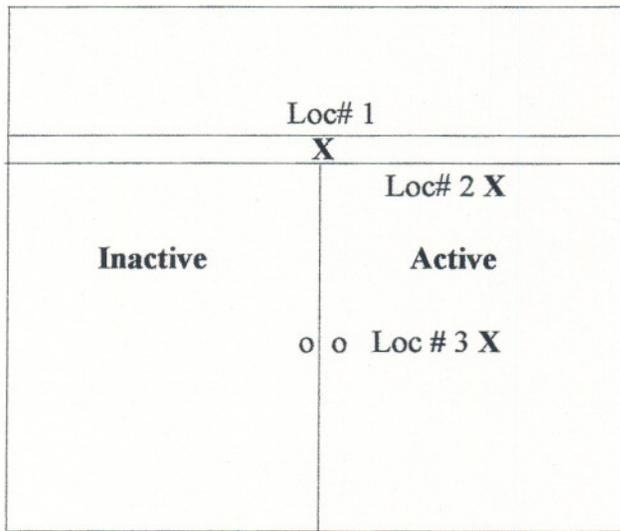
Location of CDI 5" dial indicators

STATIC AIR PRESSURE TEST Static tests were conducted in accordance with DCBCCD PA 202
Performance Test Results Specimen # 2 PA 202

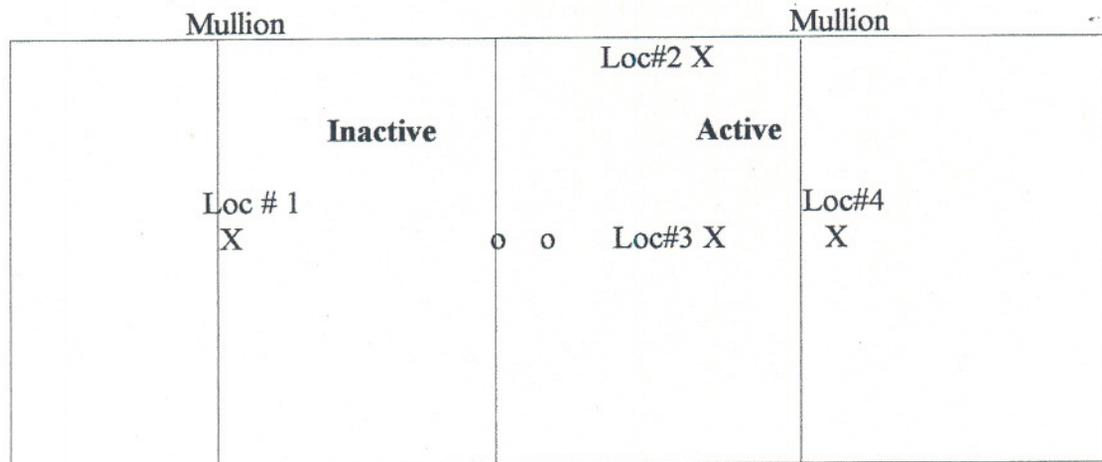
Specimen # 3

O X X O
 Location of CDI 5" dial indicators

STATIC AIR PRESSURE TEST Static tests were conducted in accordance with DCBCCD PA 202

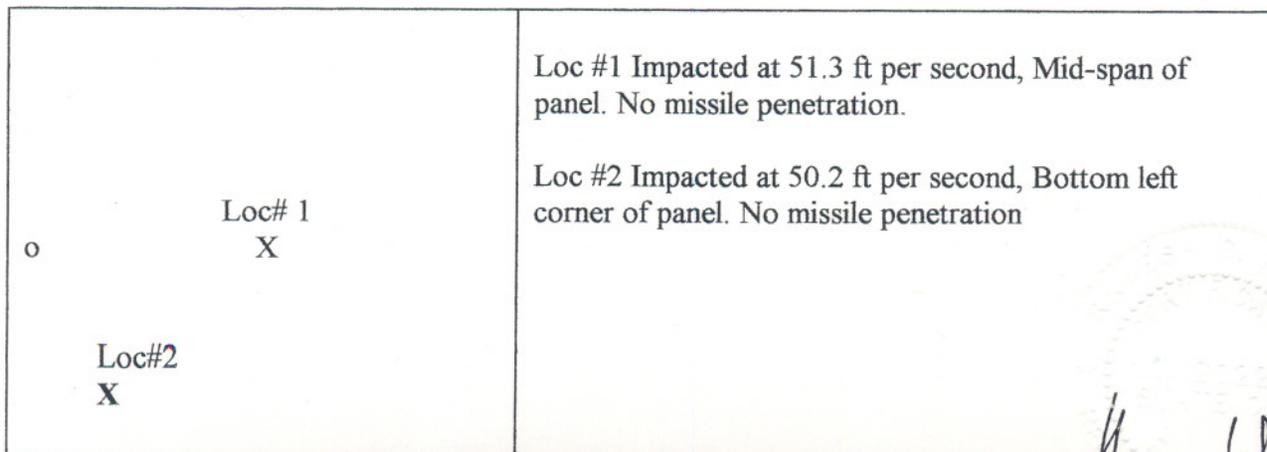
The specimen was impacted with a 8ft. long, 9lb., 2" x 4" at the following locations:

Loc #1 Impacted at 51.3 ft per second, Mid-span of panel. No missile penetration.

Loc #2 Impacted at 50.2 ft per second, Bottom left corner of panel. No missile penetration

Performance Test Results Specimen # 4A PA 201 (Large missile)
